Rebuilding of an ancient castle including a base-isolated museum hall

S. Sorace¹ & G. Terenzi²

A design hypothesis to rebuild the main wing of the medieval castle of Prampero, devastated by a violent earthquake in Friuli in 1976, is presented in this paper. The intervention suggests that the building be used as a museum to exhibit the artistic heritage of the owners. This new destination prompted some architectural rearrangements of the interiors of the building as compared to its original configuration, while preserving the global volume and the interstory heights, as well as the outer appearance of the castle, including its façades, the roof and all finishes. The structural design includes some updated traditional solutions for the masonry walls, the wooden floors and the roof. At the same time, a non-conventional solution is adopted for the floor accommodating the main exhibition hall, consisting in the incorporation of a base isolation seismic protection system. Details of the design analyses carried out, with special regard to the numerical enquiry developed on the base-isolated floor, are provided in this paper. Selected drawings of the technical solutions adopted, are also

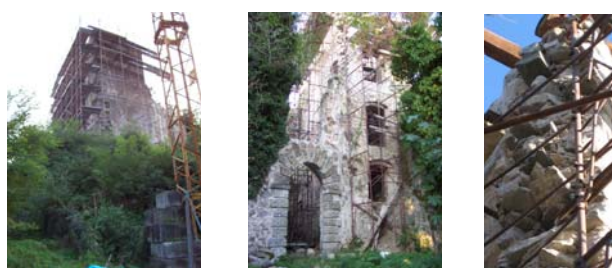
Figure 3. Photographic views of the northern tower during the restoration works

A global photographic view of the northern tower during the restoration works, and detailed views of its front, including the survived main door of the central part of the castle, and the stone blocks already arranged to be connected to the perimeter walls of the central zone, when it will be rebuilt, are shown in Figure 3. It can be observed that the original stones recovered from the collapsed walls will be used for reconstruction, in combination with high-strength hydraulic-lime mortars.
